16 WATER FINANCE & MANAGEMENT OCTOBER 2017

TURNING DATA INTO DECISIONS

Washington Suburban Sanitary Commission Prioritizes Water Main Replacement with Comprehensive Inspection Program

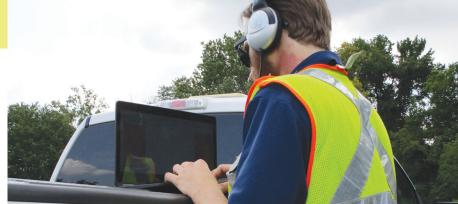
A non-intrusive, non-disruptive technology, Echologics' ePulse technology assesses pipelines through the use of acoustic sensors. It collects data that, when averaged, indicates minimum wall thickness of pipe segments and checks for leaks throughout the water distribution system.

In 2011, the WSSC was introduced to acoustic-based technologies from Echologics that could non-invasively detect leaks and inspect pipe conditions. A non-intrusive, non-disruptive technology, Echologics' ePulse technology assesses water mains through the use of acoustic sensors. It collects data that, when averaged, indicates minimum wall thickness of pipe segments and checks for leaks throughout the water distribution system. To determine the viability of the condition assessment technology, the WSSC decided to launch a pilot study of pipe sections it had already earmarked for replacement.
